# Failures of Vibration Supervisory Systems for Turbine-Generator Sets

by Kim A. Lovejoy, President  
Lovejoy Controls Corporation

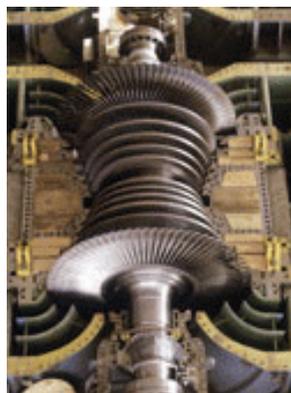
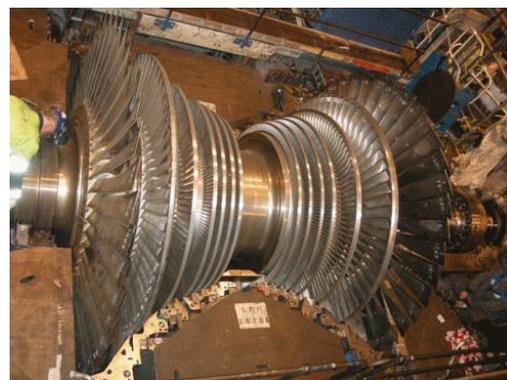
For example, let's look at a typical nuclear low pressure steam turbine rotor which has a 1800 RPM running speed and very large and long-spanned journal bearings. This rotor is symmetrical, i.e. each longitudinal side of the rotor is identical and steam flows from the center out each end to the condenser below. The Spindle Clearance Drawing indicates that the seal clearances axially are set to the following at outage inspections:

Clearance at near mid-span:

.035 inch

TSI monitors using the above limits on steam turbines are woefully inadequate and are in immediate need of reconsideration. It does not take a genius to notice that following the modal pattern of the deflection over the rotor span between bearings we can find a wide range of mils displacement. The best determination of alarm setpoints is based upon the rotating element clearances (available from the manufacturer's Spindle Clearance Drawing). Plotting potential modal deflection combinations vs. rotor clearances will provide a good "deflection to contact" measure which can establish safe operating limits of 75% of contact range. Note that the actual alarm setpoint is not a fixed number (as in the Rathbone Chart) but variable according to the modal deflection pattern.

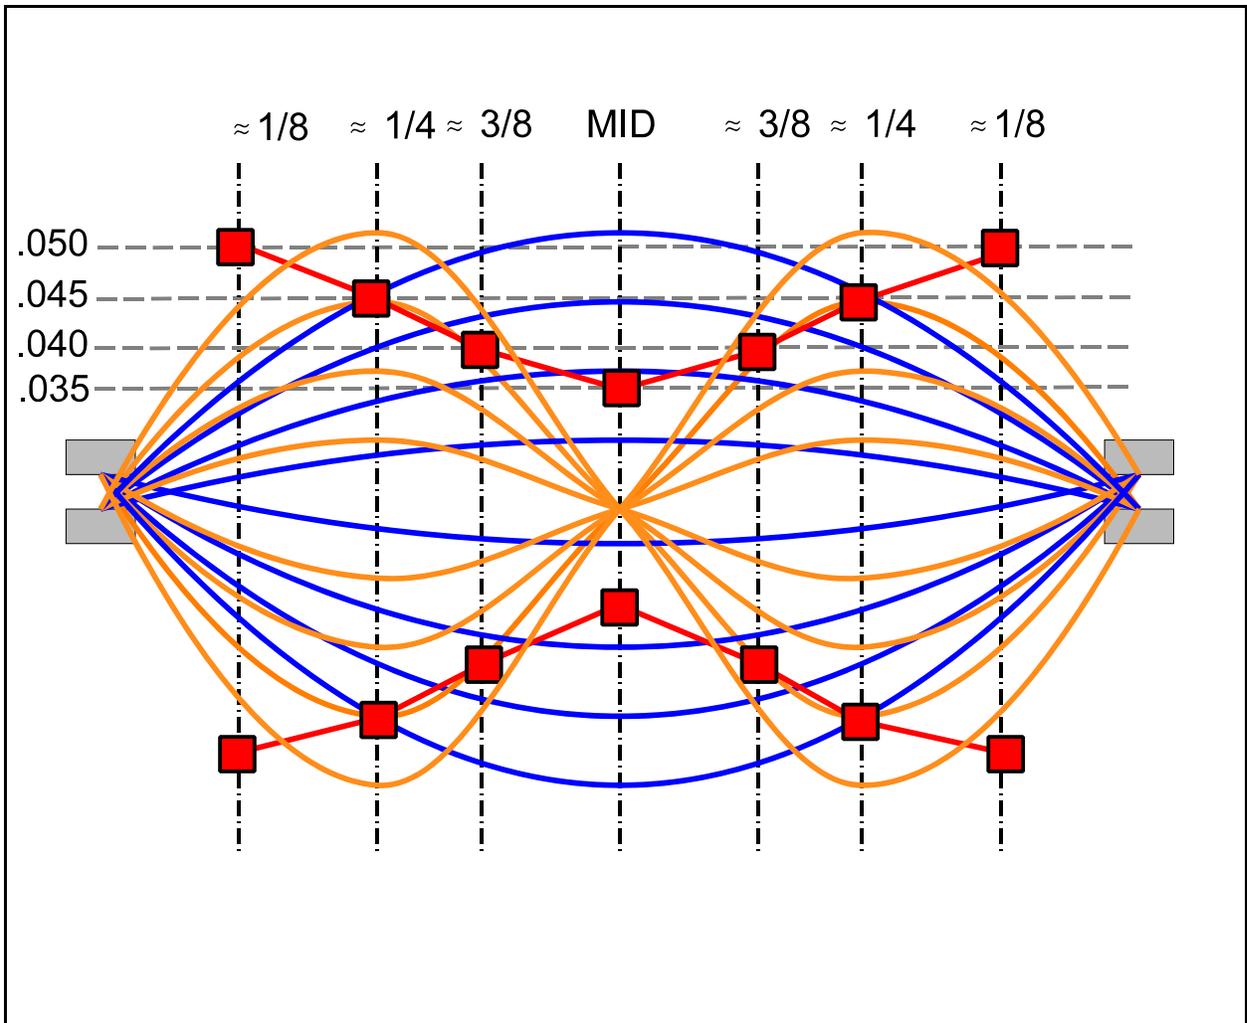
These clearances are plotted (red) on Figure 1 along with the first (blue) and second (orange), range of amplitude mode deflection curves. Several important observations are revealed in Figure 1:

- (1) If contact is to be avoided between rotating and stationary turbine elements (a good practice!), the deflection due to unbalance or rotor bow must not reach the clearance at any longitudinal position.
- (2) The relative deflection and therefore safe operating vibration levels of the rotor highly depend upon the modal shape of the deflection. For example, the mid-span .035-inch clearance is not even approached by the second mode at high amplitude but is easily exceeded by first mode at rather low amplitude.
- (3) Using the simplistic Rathbone severity of single-valued displacement alarm level is totally inadequate to warn of hard internal contact and turbine rotor damage.

Clearance at near 3/8-span:	.040 inch
Clearance at near 1/4-span:	.045 inch
Clearance at near 1/8-span:	.050 inch

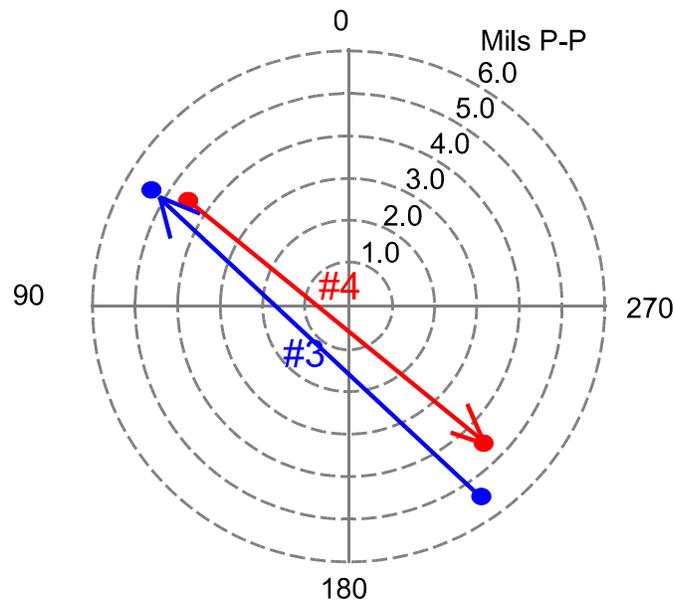
At this point it appeared that whatever happened, the turbine vibration levels slightly *decreased*, and therefore shouldn't be cause for concern. If we look at a polar vector plot of the data, however, the true magnitude of the event becomes clear.

Although the before and after vibration amplitudes (distance from plot center) didn't change much, the vector moves "crossed center" indicating a sudden and large change in rotating mass. The resulting inspection revealed the cause to be three lost shroud on the L-2 blade row, an event undetected by conventional monitoring even with amplitude envelope monitoring.

Bearing #4 4.4 mils @ 195 degrees referenced to exciter notch
